September 1, 2004

Final Report

SERDP Pollution Prevention Project 1137

Non-Destructive Testing of Corrosion Under Coatings

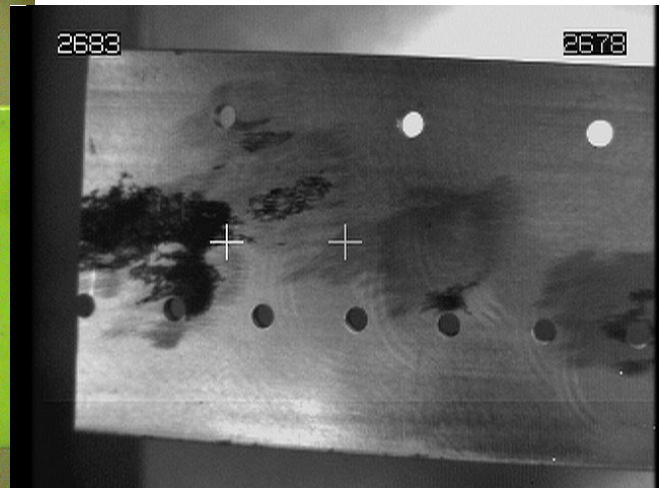
Special Note: A video was created of the corrosion survey and played at the 2002 IPR. Corrosion was clearly seen around pasteworks and splice plates on the E-8 wing.

*Same J-STARS Part Showing
Corrosion Under Primer Surface Using
IR Reflectance Technology*

Example paint taken from E-8 aircraft above shows clear evidence of corrosion under the primer coating (BMS 10-11).

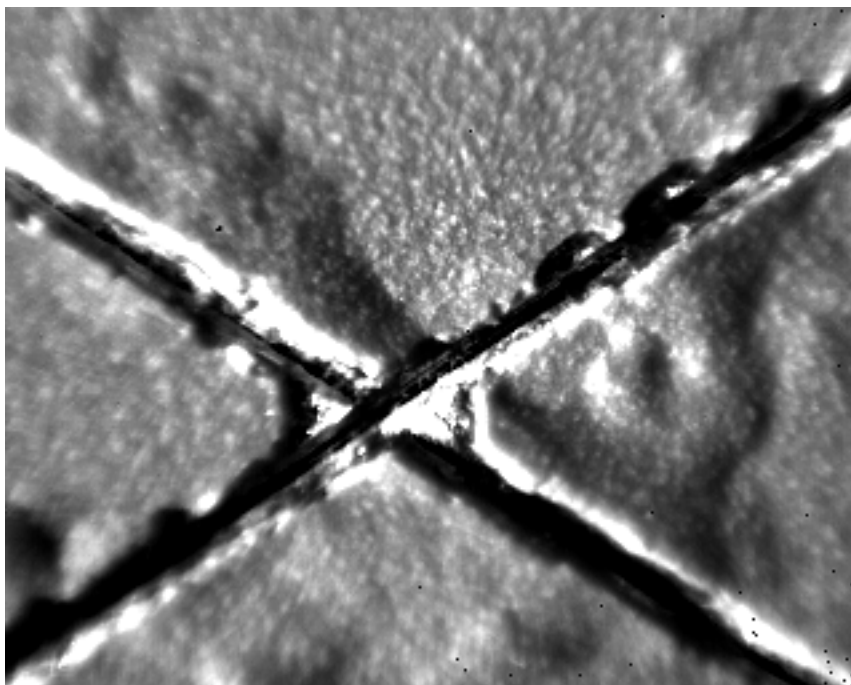
47 e3 (1 x Mag.)

Indicates corrosion in scribe as well as corrosion under coating.

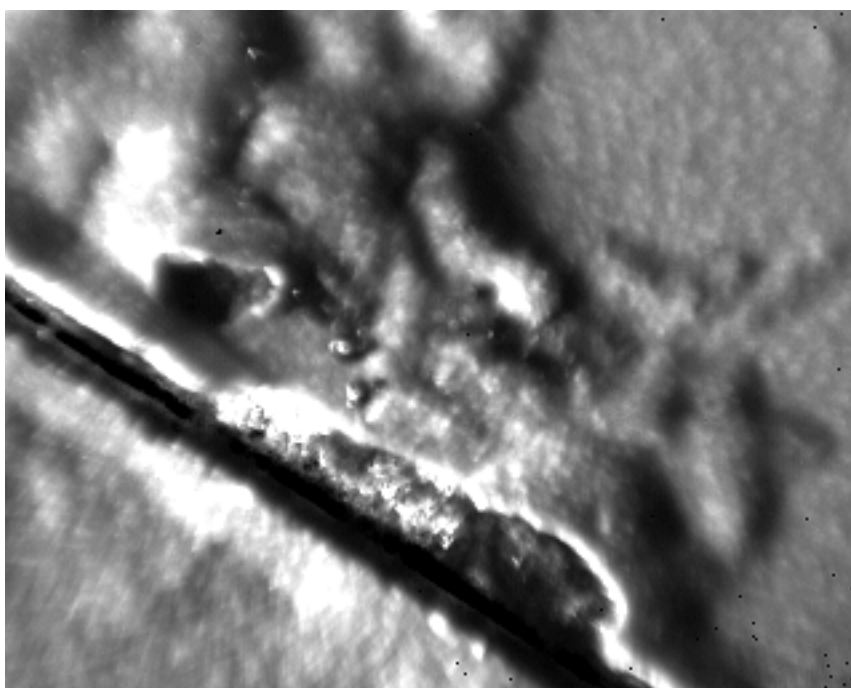
47 e3 (1 X Mag.2)

Comments same as 47 e3 (1XMag.)

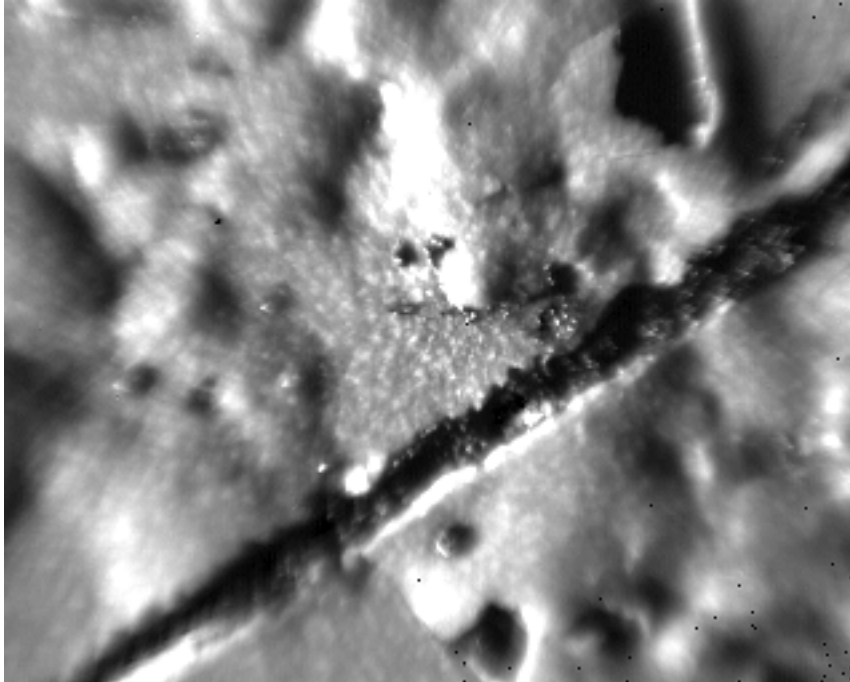
47 e3 (1 X Mag.3)
IR Photograph

Comments same as 47 e3 (1XMag.2)

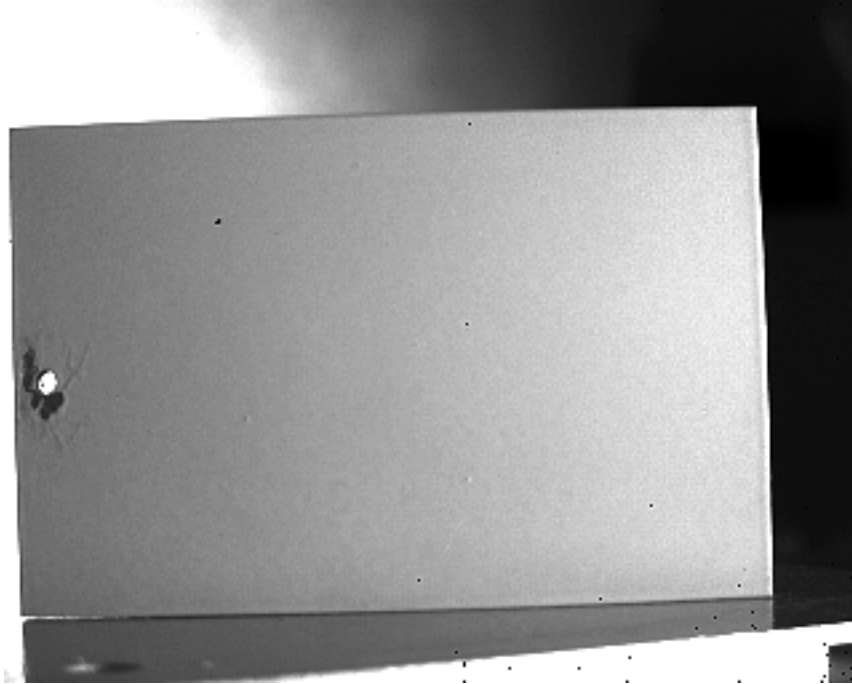
55 c3

Corrosion under coating is detectable by the hole in the panel.

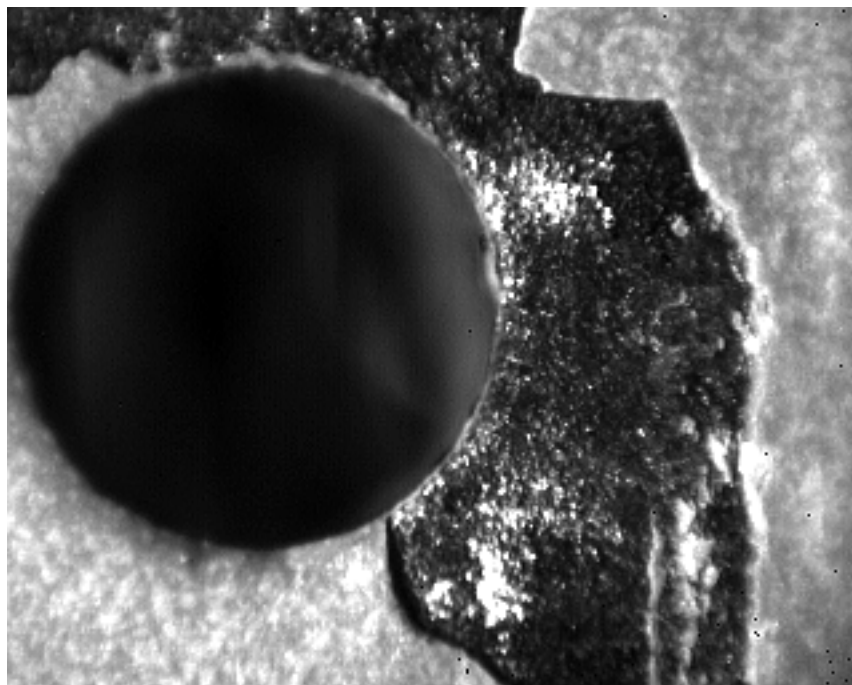
55 c3 (1XMag.)

Corrosion quite apparent under coating next to hole in panel.

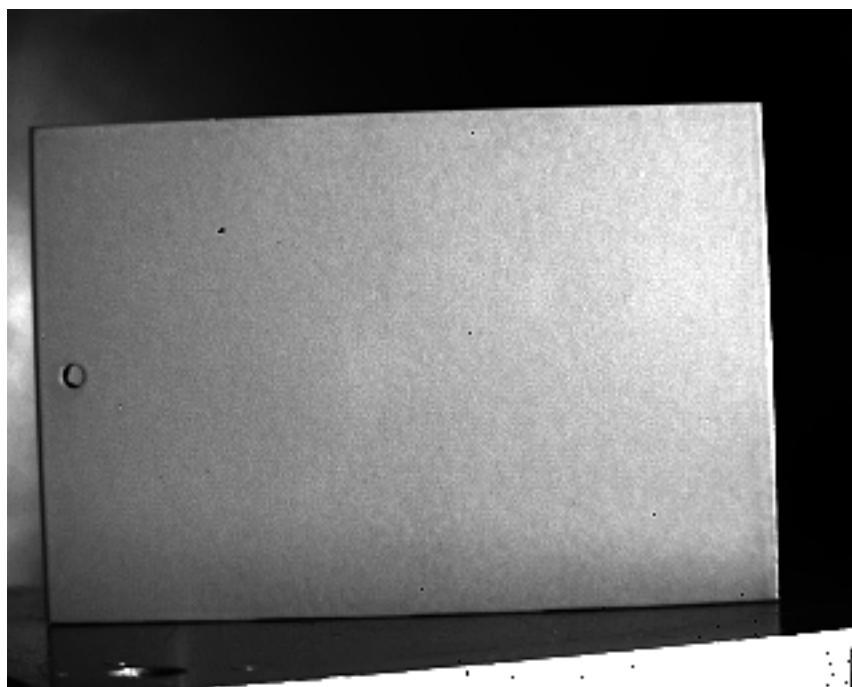
55 j1

No corrosion apparent or detectable under coating.

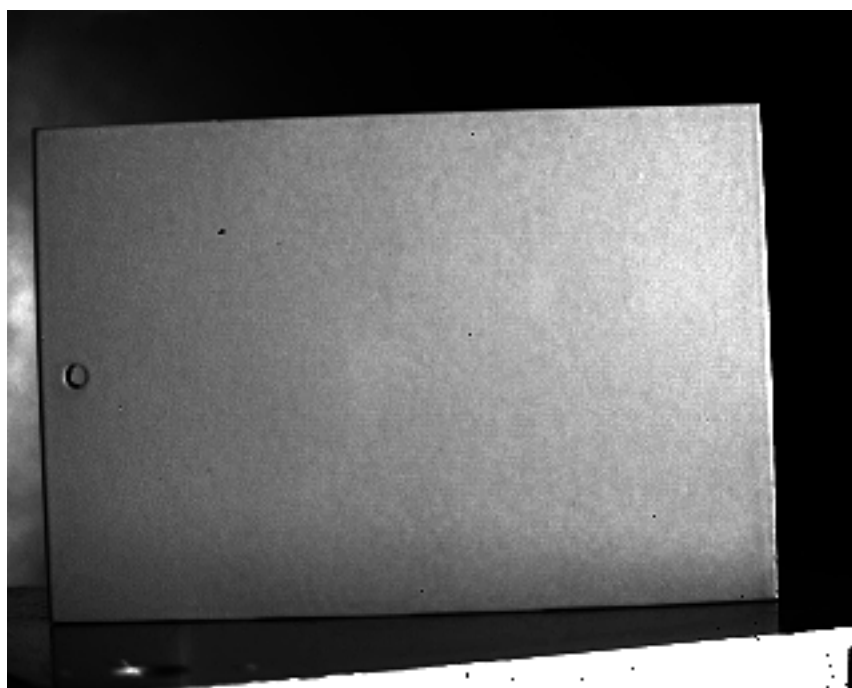
55 j1b

No corrosion apparent or detectable under coating.

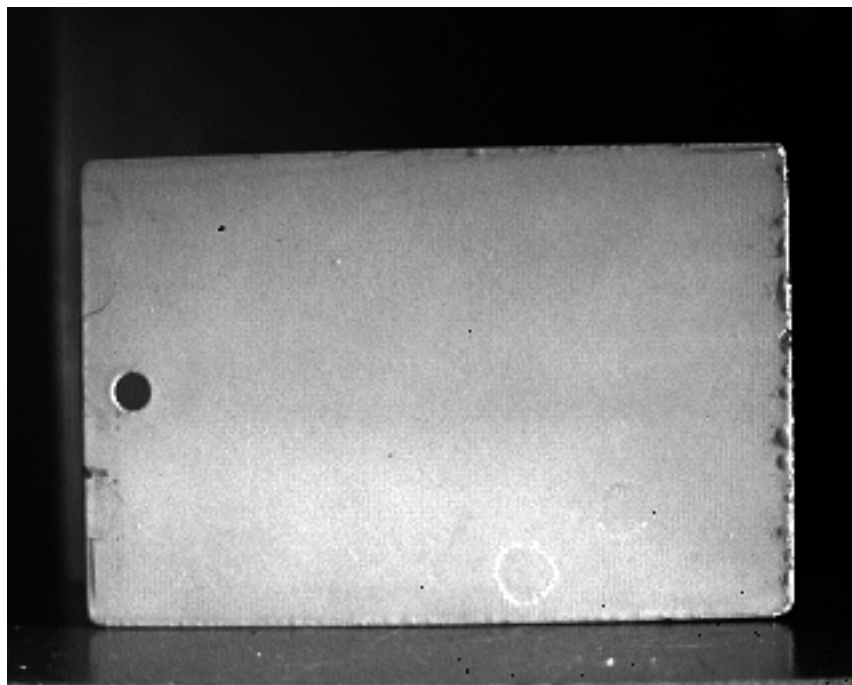
7 c2a (Front Side)

Corrosion Detected on Edge of panel Right Side.

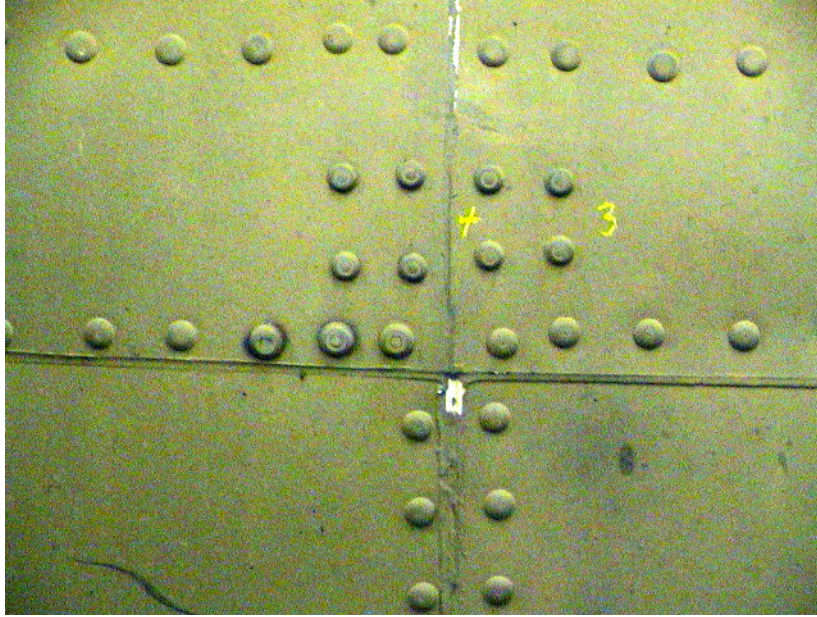
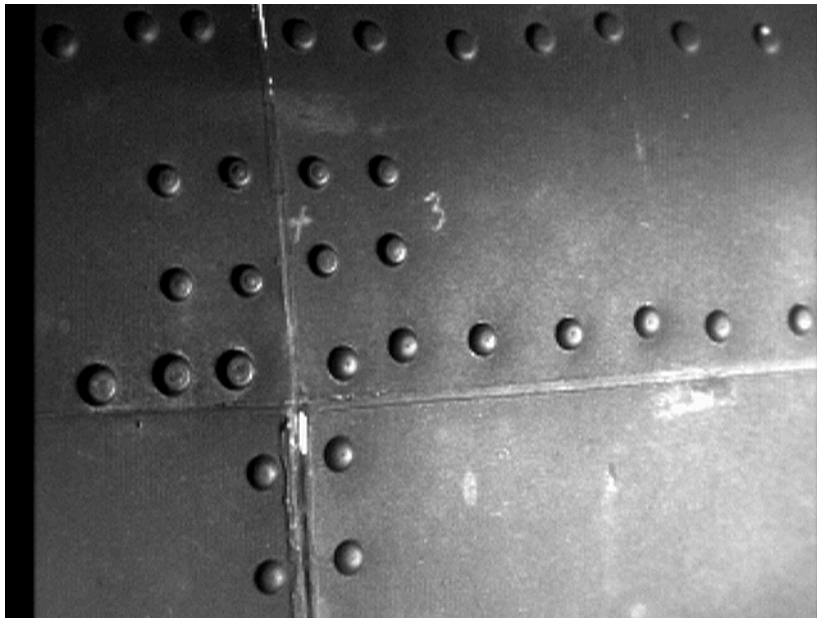
Visible and IR images of Boom Position 2. Note the “footprint” in the IR image.

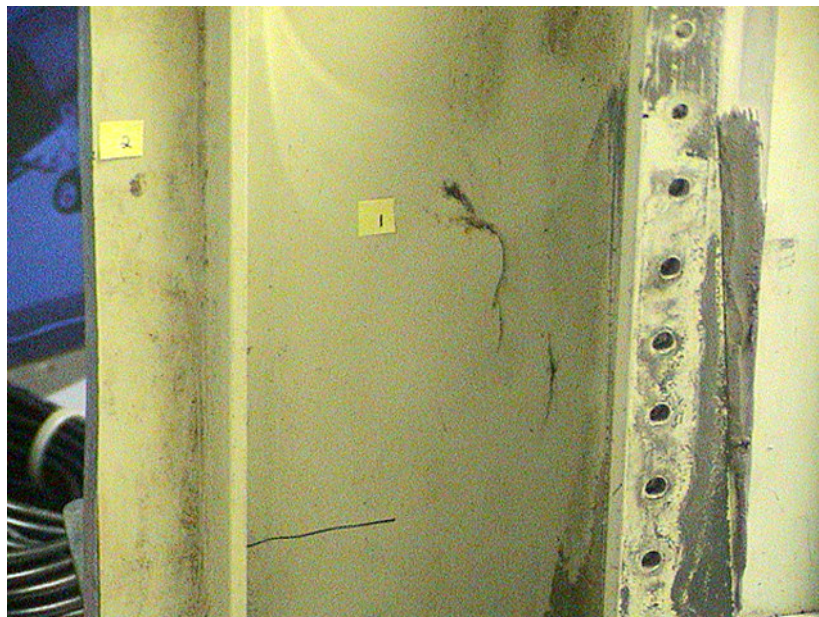
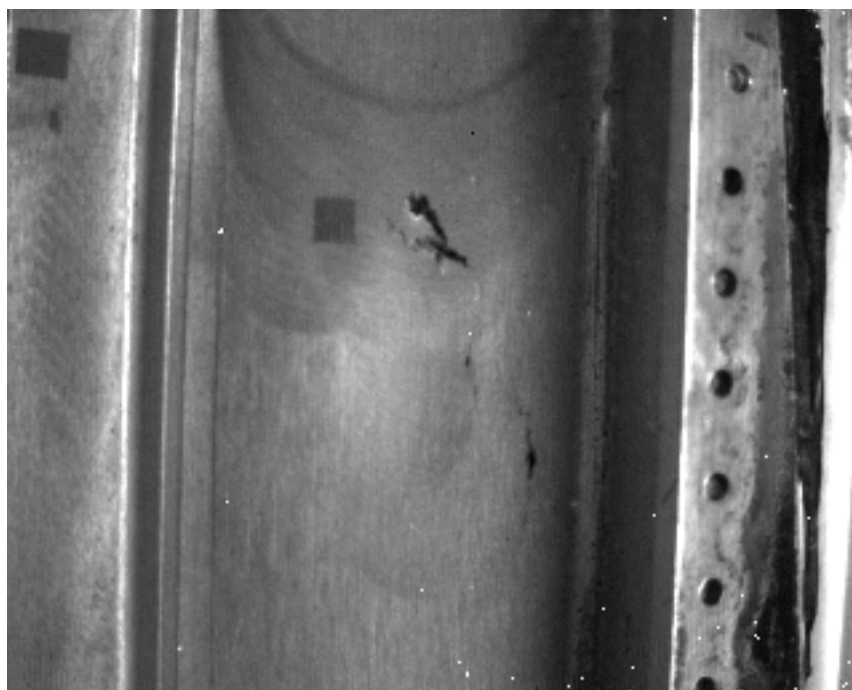
Visible and IR reflectance images of spot 1 and 2. The IR image shows the metal grain structure underneath the paint. Rework and corrosion can be seen in the IR.

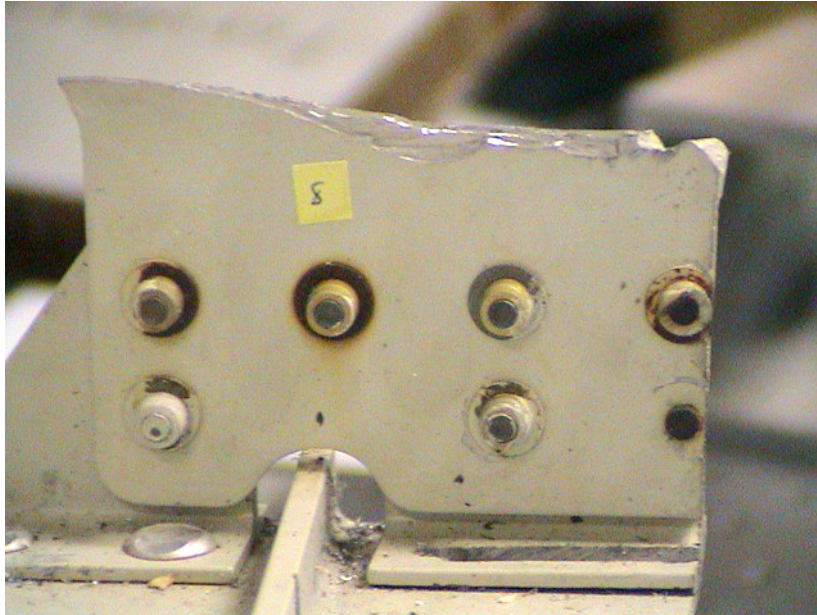
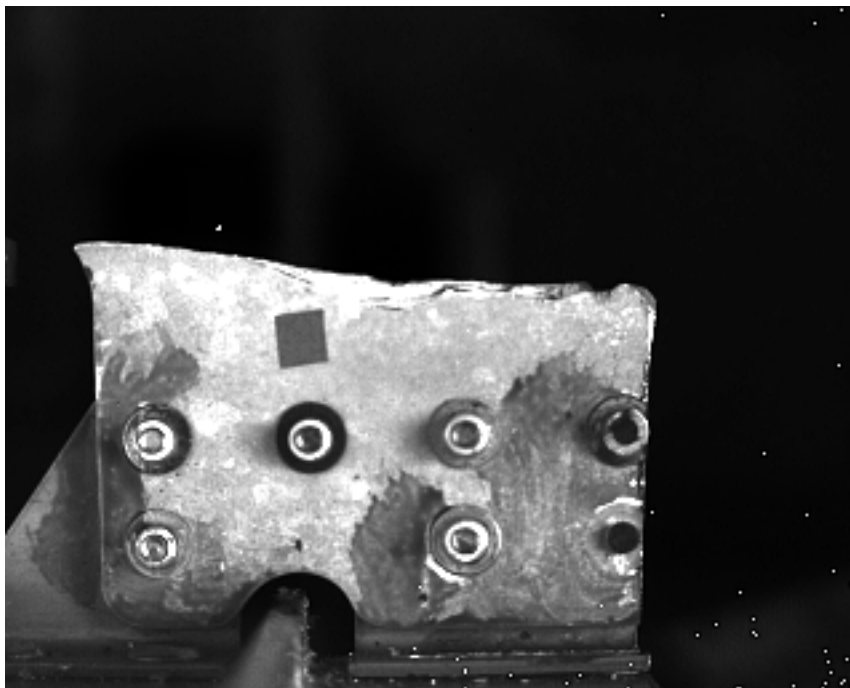
Visible and IR reflectance images of spot 8. The IR image shows the possible rework underneath the paint. The IR image reveals features not seen in the visible image.
